## Conservation and restoration works of the Four Sewers Fountain in Daganzo (Madrid, Spain)

**Abstract:** The paper's field focuses on the Restoration of the Four Sewers Fountain of Daganzo and the improvement of its immediate environment, linked to the Plan of Fountains and Historical Gardens of the Regional Government of Madrid.

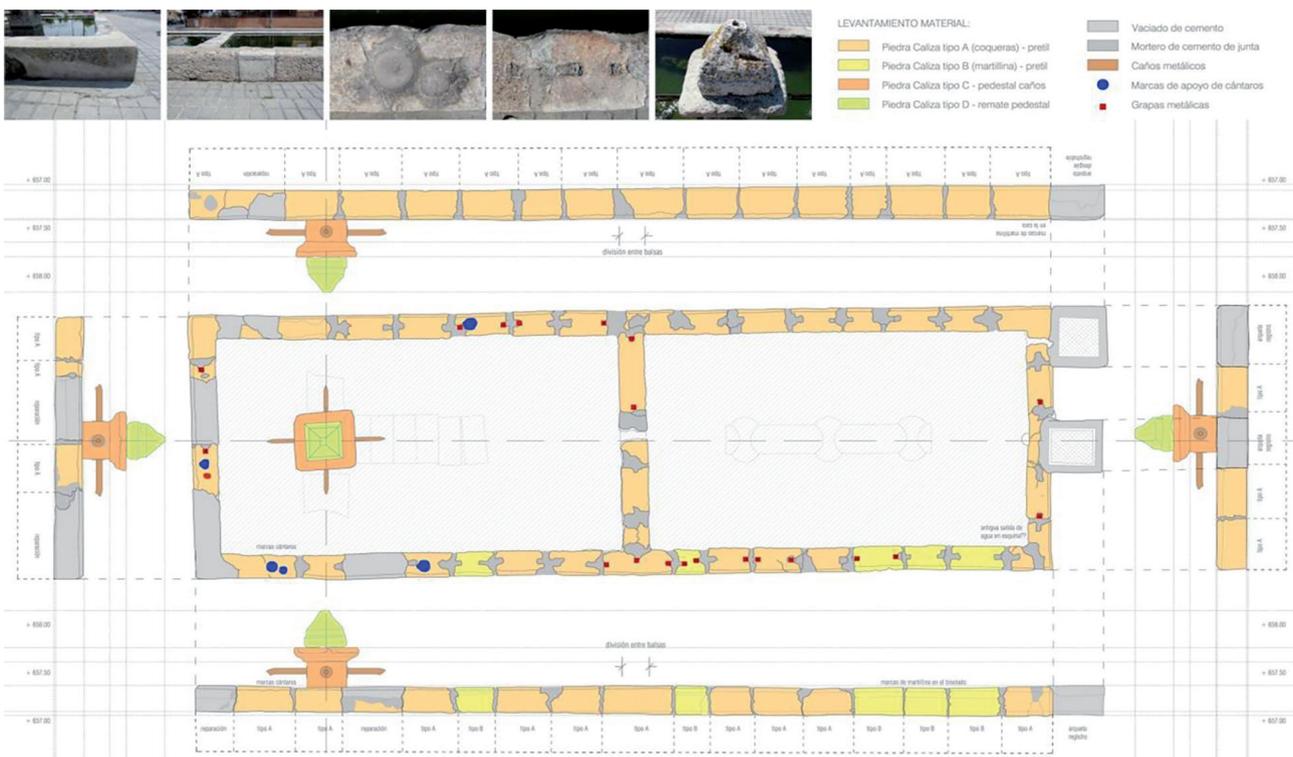
**Figure 1.-** Constructive analysis of the initial stage of the fountain (2013).

The construction is made of limestone blocks, and it is composed by a central body with a square pedestal of 40 centimeters that holds a pyramidal shaped finishing piece on top. A long sewer emerges from every of its four sides, and they pour the water into a two sinks pylon. The perimeter of the parapet is 2.75 by 8.40 meters, made of limestone, too. The blocks used to build it are 26 cm width by 75 cm height and variable length, with chamfered corner edges.

- There are two limestone types: class A, which is darker, with hollows and more abundant; and class B (pieces 09, 13, 17, 18 and 19), less frequent, of a lighter colour and a special texture got by small hammer blows, that are the ones suffering a more severe level of damages such as alterations, disgregations and efflorescences. Even though the reasons of the use of these two types are not clear, it seems the second type was used during a later restoration works, that consisted of a replacement of the original –but damaged– class A pieces by newer class B blocks.

- Pyramidal finishing element on top of the pedestal is a movable cover, for inspection of the inner water conduits, that may belong to the fountain from its very beginning or be part of a later addition. So, its top component, maybe a ball, is lost and left a hole only.

- The lead of seventeen staples remain in place, linking the top part of the parapet blocks.

- There are historical traces worth preserving, such as abrasing marks due to animals action while drinking, or due to ceramic jugs continuously placed towards the sewers during the refilling (Velasco 2007).

- Original water drainage went through a corner spillway, that is no longer used. Two newer spillways were added laterly: one is at a lower height so to connect to another close fountain prior to pour the water onto the stream; and another one connects to the local sewer system.

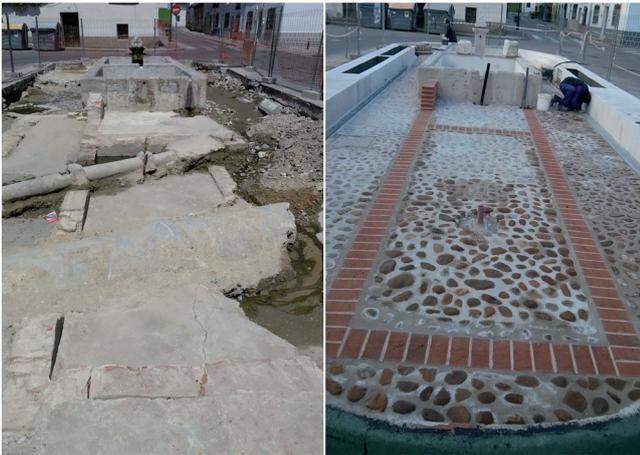
The archaeological excavation resulted into the discovering of important remnants of the old laundry brick construction, together with the original cobblestone boulder set around the pylon and the original slab foundation, made of stone (Mendoza 2014). So, team proceeded to study, document and integrate it in the restoration project [figure 2].

**Figure 2.-** Comparison between the archaeological excavation and the final restoration.

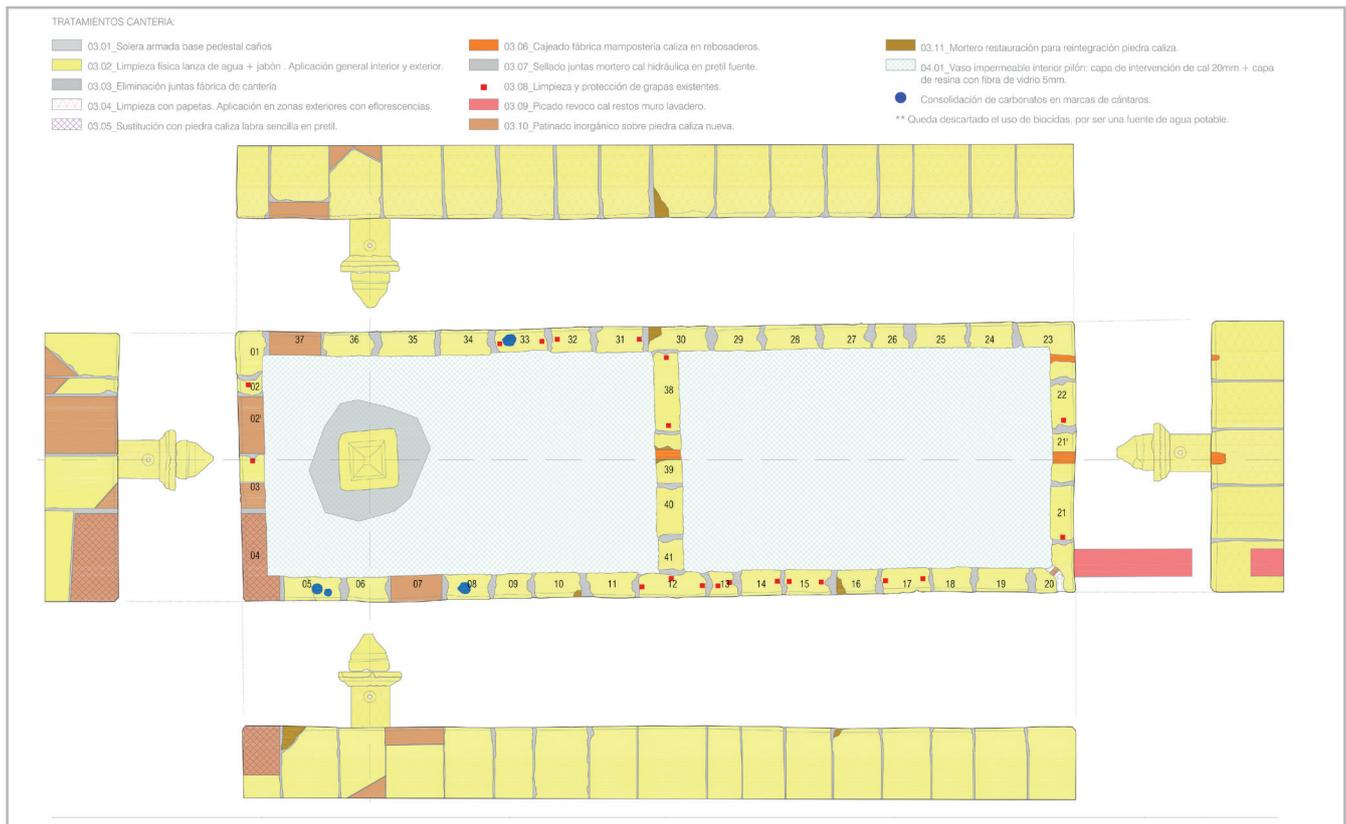
**Figure 4.-** Planning diagram of the conservation-restoration treatments.

Aware of the importance of the fountain, the methodology considered its documentary, architectural and significant nature values. The role of the multidisciplinary team was crucial, as all actors intervened, decided and valued the different options and treatments to get to an agreement. All these treatments were tested in small parts of the fountain and valued together before its complete application. The most relevant restoration works were [figure 4]:

- Cleaning process main objective is the preservation of the good, in order to get a real view of current situation and prepare stone for the subsequent treatments.

Mechanic cleaning process consisting of white aluminium oxide micro-projection was finally chosen as the most appropriate method. The equipment used for this purpose was a mini-abrasion machine, model CTS Art 100, able to work at low or very low pressures so as to use a wide range of outlet nozzles, that were used according to the characteristics and thickness of the layer to be removed.

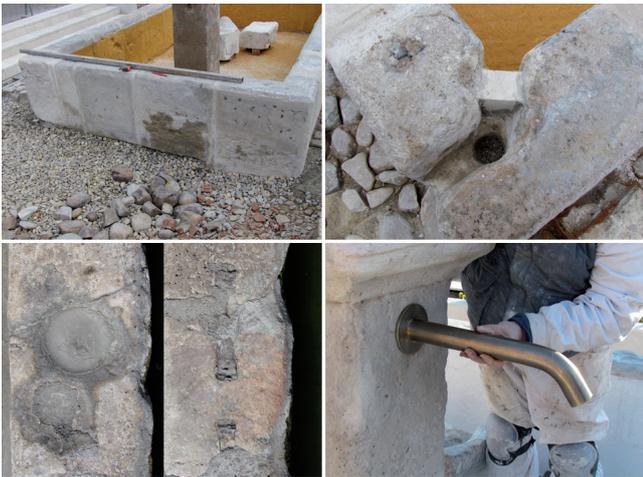
**Figure 5.-** Restoration details: substituting cement for limestone and pylon waterproofing; discovery of the primitive spillway corner; conservation and protection of the original remains; new sewers made of brass as per the primal design.

- Substituting cement for limestone and/or mortar [figure 5]. Once cleaning process was over, it was possible to check the state of old Portland mortar additions, in order to evaluate removal steps and techniques to use. This procedure consisted of mechanic manual elimination prior to its substitution, done using limestone pieces and lime mortar.

The material used for the purpose of the volumetric restoration was based on size and stresses to resist analysis. Hence, bigger volumes were substituted by limestone mortar prostheses and smaller ones were replaced by lime mortar reconstruction.

- Pylon waterproofing. This is a major problem, frequently found in historical fountains. Some procedures prevail waterproofing against stone material preservation, and resins are massive and indiscriminate applied on the stone, regardless impairments. In our case, a long term view led to plan a future reversibility of the treatment: final solution consisted of including a layer of intervention between the stone and the waterproofing, thus it can be easily removed if required, without affections on the original stone.

The layer composition consists of aerial lime and marble powder plaster, left for weeks to make sure carbonation process was correct. Then, an acrylic primer (Acril 33) was applied for a double purpose: union layer and a reversibility guarantee thanks to its thermoplastic behavior. Lastly, waterproofing of the pylon was done by means of polyurethane resin (five layers) and two superficial layers of marble powder and limestone to get a similar surface appearance to the original fountain lime blocks.

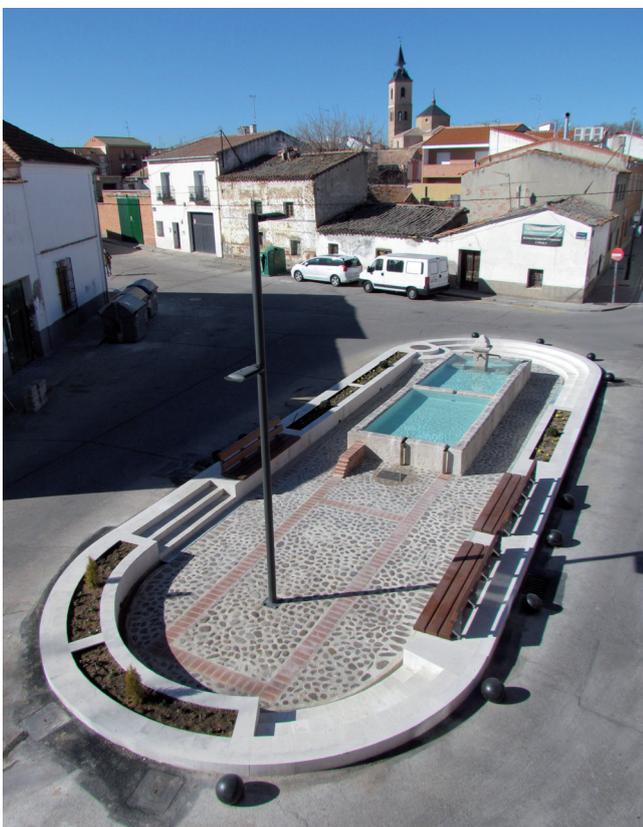
What is more, thanks to the actions fostered by the General Directorate of Cultural Heritage of the Community of Madrid, this urban space has been regenerated: intervention treated the close environment, included new social uses and integrated new requirements such as urban facilities in a discrete way. To sum up, it got a full equipped and interesting social area around the fountain as prime character [figure 6].

**Figure 6.-** image of the intervention in the Fountain Square (2015).
